# Effects of Time and Land Use Land Cover Change (LULCC) in the Dimension of the Gully Expansion and Soil Particles Loss at Ibeziako Erosion Site in Nsukka Urban, Enugu State, Nigeria

**Original Research Article**

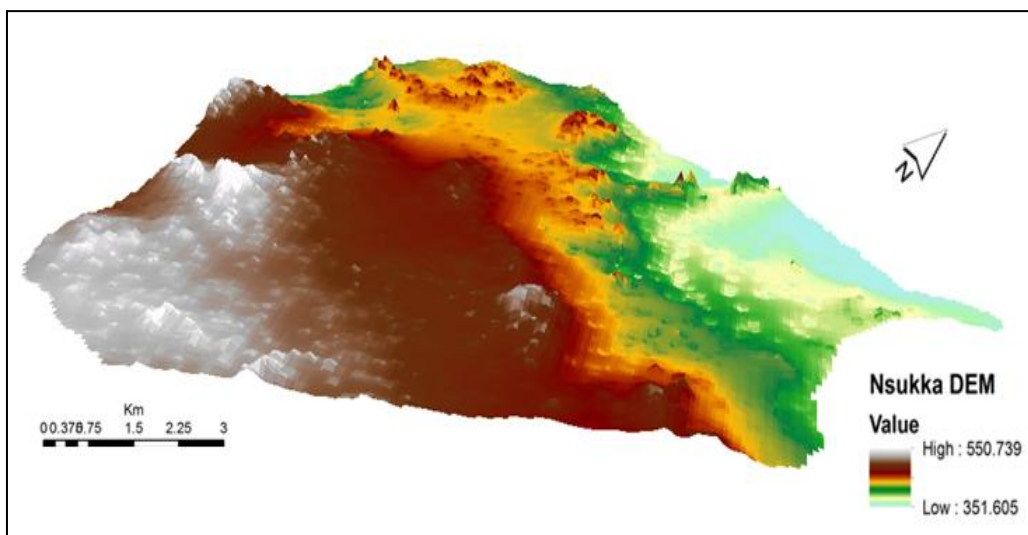
**Fig. 2. Digital Elevation Model (DEM) of Nsukka Urban**  
 Source: USGS, modified by the authors (2020)

Horton and others have proposed that there is an orderly development of drainage basins according to a set of principles, which Marisawa [51] calls the “laws of drainage composition.” Horton noted that the number of streams of different orders in watershed decreases with increasing order in a regular manner known as the law of stream numbers [52]. There is a natural pattern of flow, whether of streams or floods. Flow directions have always been from uplands to lowlands in all directions [53], and in most cases along fault lines. The same is the case of Nsukka Urban (Fig. 2).

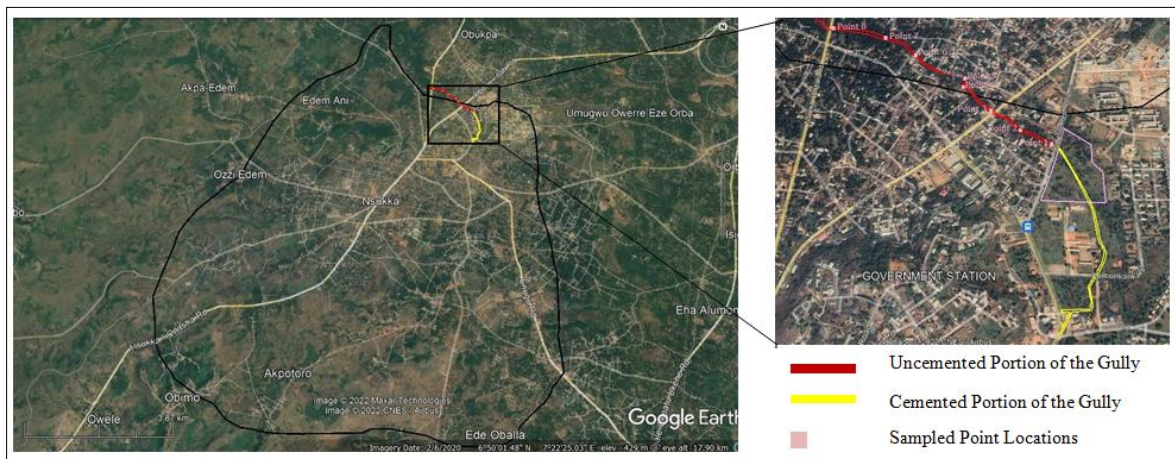
**Fig. 3. Google Earth Image of Nsukka Urban showing the road networks as the flood path ways channeled and diverted through the University of Nigeria main gate (depicted in yellow) towards Catering Rest House Road to Onuiyi and Alor Uno (depicted in red)**

concrete gutters and culverts is rill erosion. When second order of flood joins together, a third order of flood is formed and so on. Based on the topography of Nsukka Urban, whenever it rains, all flows are directed naturally from the south to the north of the area and this concentrates all the flood channels northward and a greater percentage of the floods (about 90%) meet at University Road as was channeled through the University of Nigeria Secondary School premises. At Catering Rest House Road, the flood drainage channels from Obukpa Layout joined the main channel from University Road, thereby increasing the volume, velocity and erosive force. As the gully cuts its way through Onuiyi to Ibeziako Street, Onuiyi Road drainage channels joined the main gully channel too. Ogurugu Road, Ugwu Awarawa and Ibeagwa Road drainage channels were joined at Onuakachi village in Alor Uno where all the debris are deposited (Fig. 3) and (Plates A - L).

The gully length is 1674 m, stretching from Catherine Rest House Road to Alor Uno as depicted in red (Fig. 3). Therefore as at 2020, the total soil particles loss (SPL) from the gully site due to erosion is estimated to be 18,547.92 m<sup>3</sup> (1674 m \* 11.08 m<sup>2</sup>) or 18.548 tons.

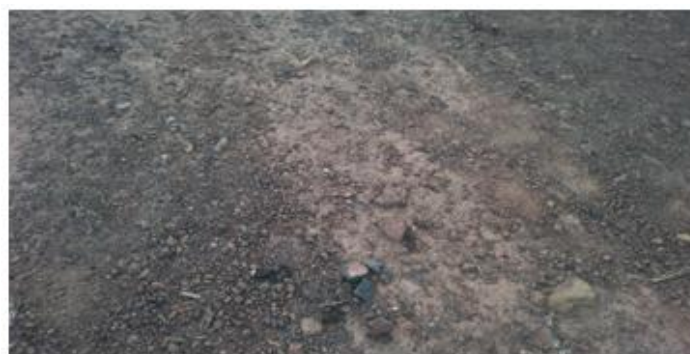
**Plate A. Sheet and Splash erosion at the base of northeastern slope of Aso Hill in 2016**

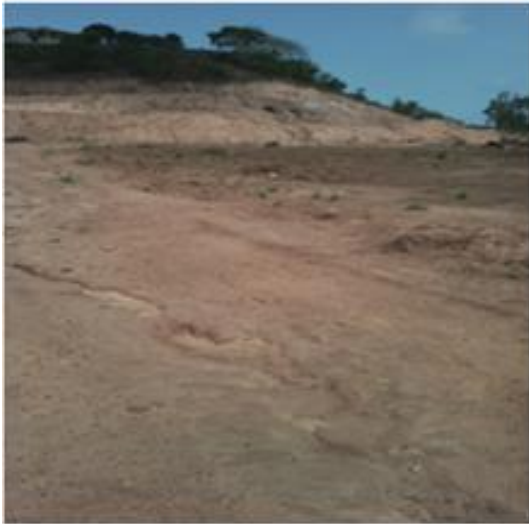
**Plate B. Rill erosion at the base of northeastern slope of Aso Hill in 2016**

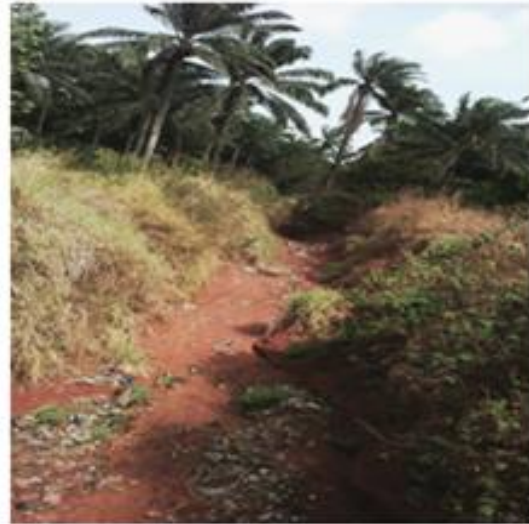
**Plate C. Gully erosion section at Onuiyi in 2016**

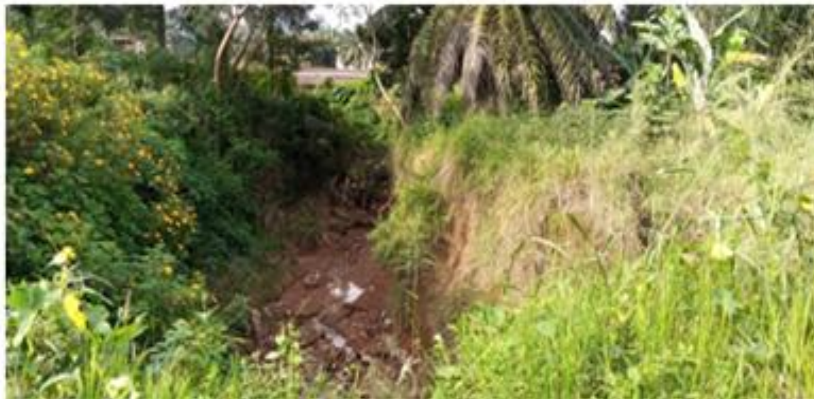
**Plate D. The same gully erosion section at Onuiyi in 2020**

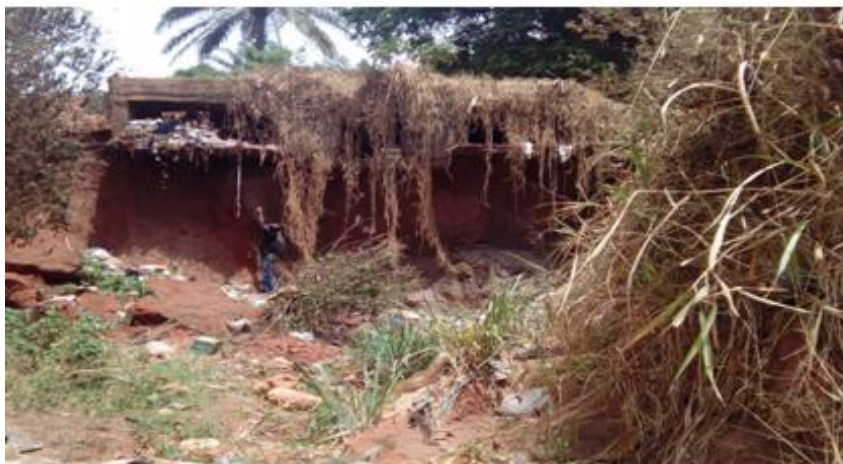
**Plate E. Gully erosion at Onuiyi Road Culvert in 2016 (Note the author, whose height is almost half way the gully depth at 1.9 m)**

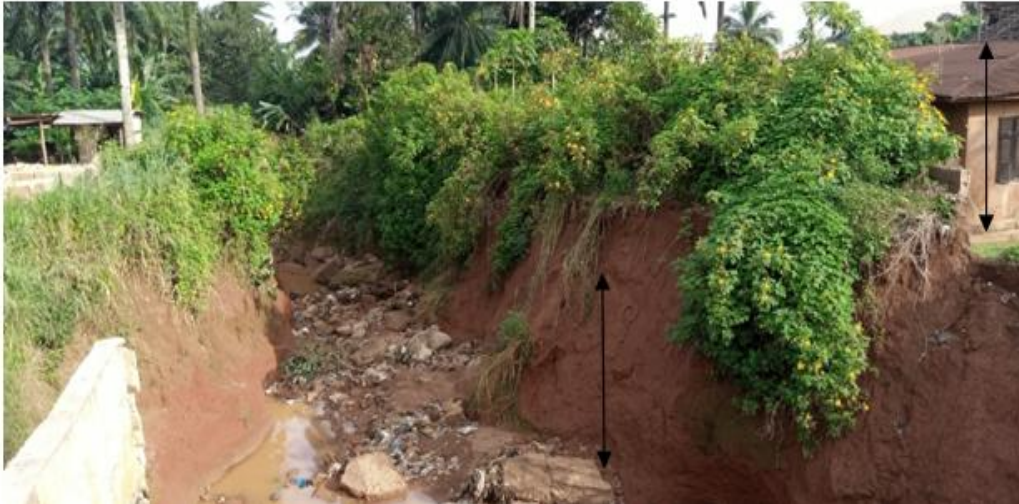
**Plate F. The same gully erosion at Onuiyi Road Culvert in 2020 (Note the house around the gully site, with the height of the house about half of the gully depth at 3.84 m)**

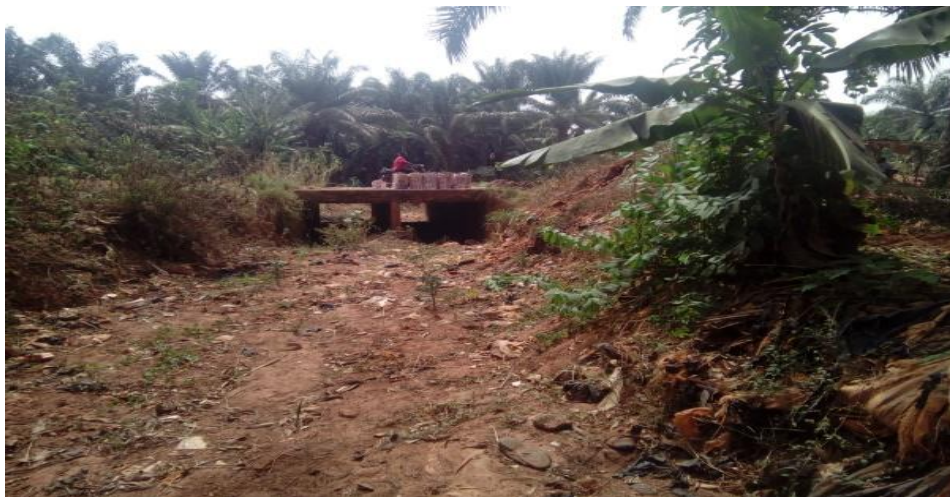
**Plate G. Ibeagwa Road Culvert at the Alor Uno end of the gully depositional plane in 2016**  
*Source: Authors Fieldwork, (2016 and 2020)*

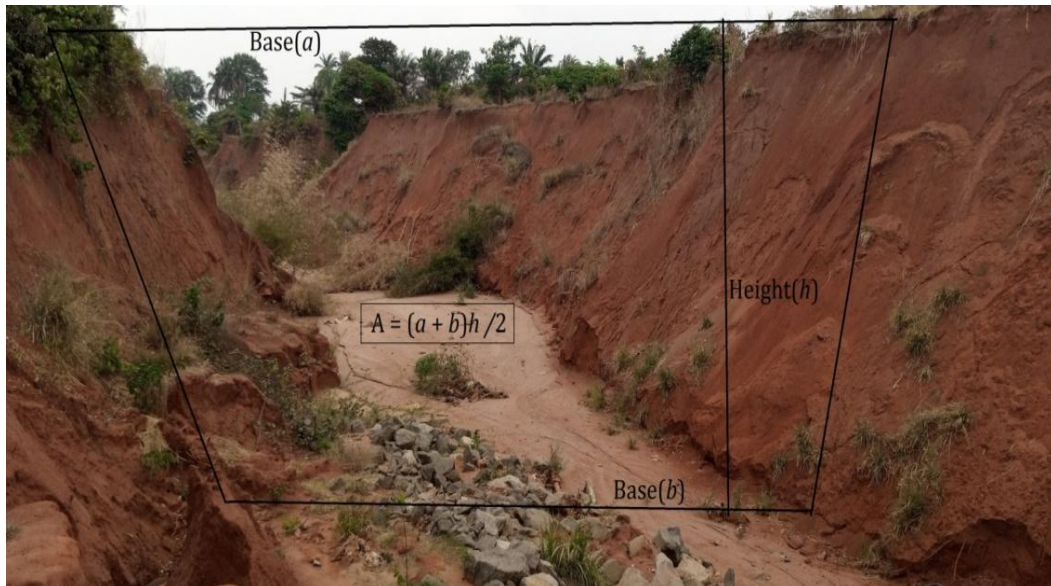
data collection. Measurements of the width (bases), depth (height) and the coordinates of eight (8) different points along the gully channel; from the lower (end), through the upper (head) parts of the gully (Fig. 3), were taken, using a 50 m, 7.5 m steel tapes and a global positioning system (GPS). The length of the gully was also traced using GPS logger. The cross sectional areas of the eight (8) different sampled point locations in the gully were determined as in the example below using the formula given as:

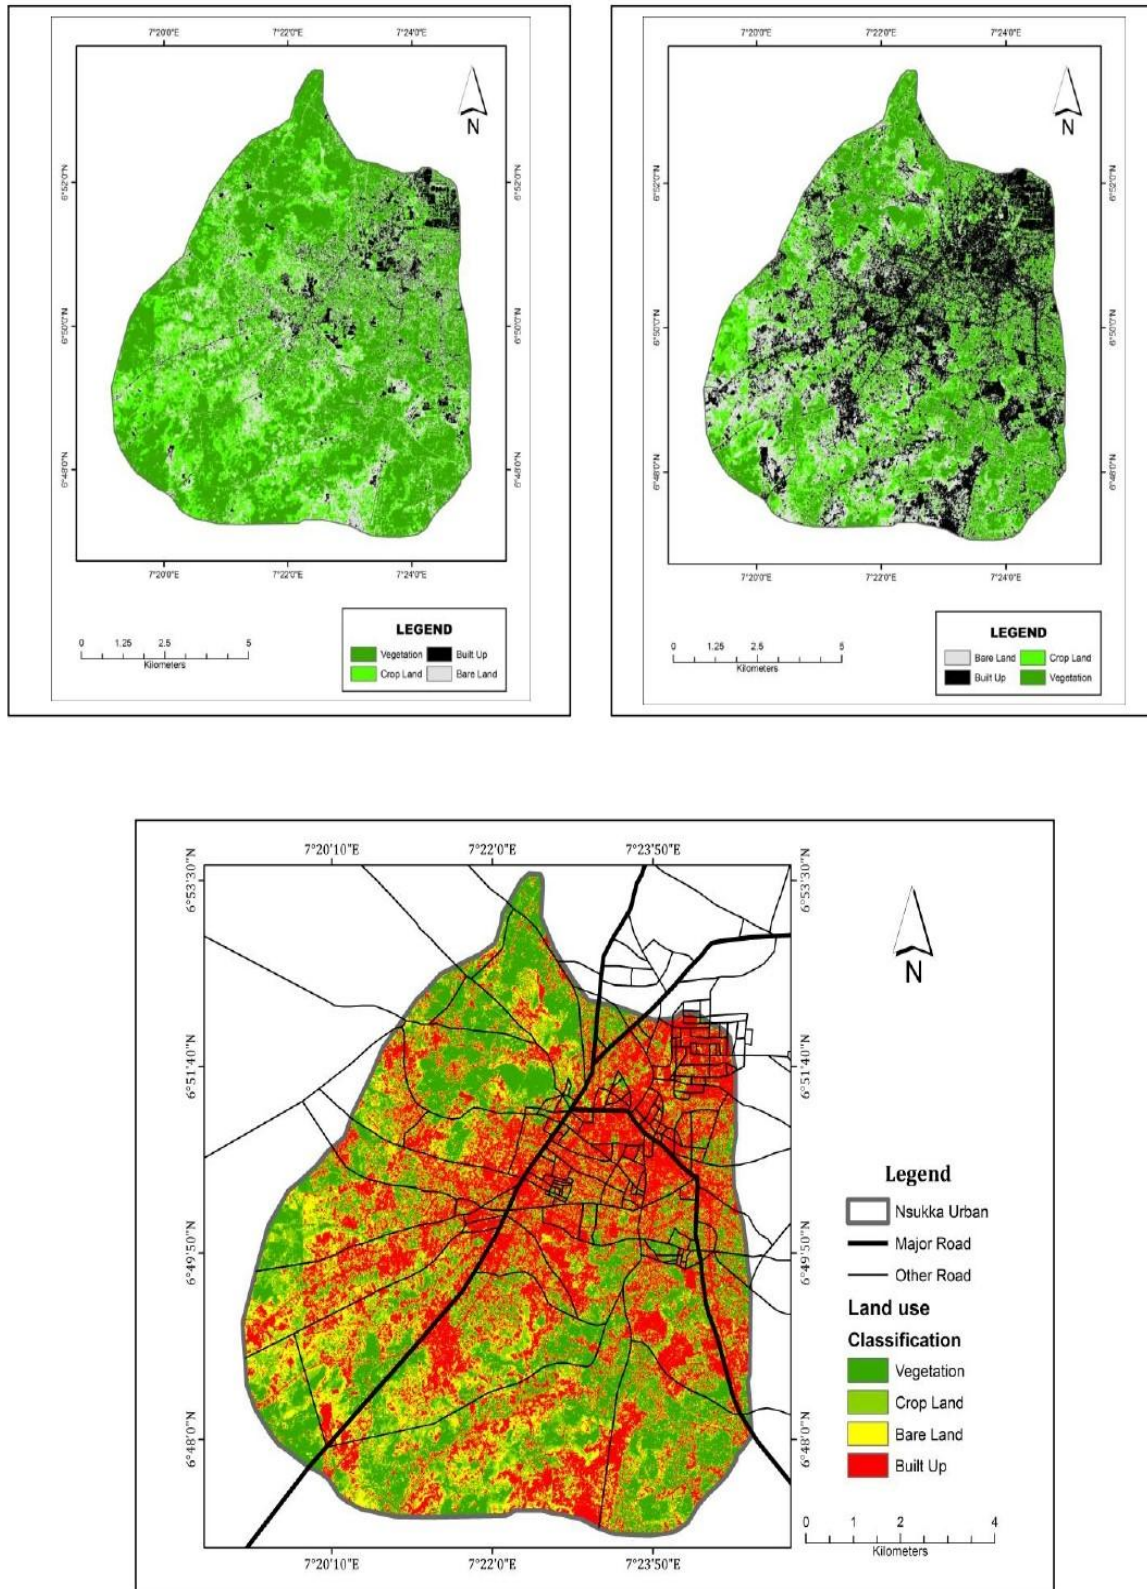
**Fig. 4. Land Use Land Cover Change of Nsukka Urban in 2005, 2015 and 2020; Colour differences used in 2020 version is to differentiate roads from Built Up areas**

The land use land cover distributions for each study year as derived from the maps are presented in table 2. The study years were randomly selected and mapped, to depict the various change levels of the different land uses. The study years mapped were 2005, this was the year that preceded the 2006 population census in Nigeria), followed by 2015 which was also the year that preceded the first reconnaissance visit of the gully site in the study area, and then 2020, the year that the field work of the entire study area was carried out (Fig.4).

In the analysis below (Table 2), the percentage of vegetation cover was 41.24% in 2005; it came down to 27.97% in 2015 and to 16.82% in 2020 respectively showing a general decrease of 24.42% from between 2005 and 2020. Crop land increased from 29.83% in 2005 to 32.42% in 2015 as a result of increase in agriculture, and later decreased to 24.02% in 2020 respectively showing a general decrease of 5.78% from between 2005 and 2020. Bare land was on the increase from 20.88% in 2005 to 28.09% in 2015 and decreased to 27.64% in 2020 respectively showing a general increase of 6.76% from between 2005 and 2020. Built-up area increased to 23.47% from between 2005 and 2020 in the tune of 8.05% in 2005 to 11.52% in 2015 and to 31.52% in 2020 respectively.

Land cover classification (built-up area and bare lands) which are responsible for high runoffs generation recorded an unprecedented increase of 6.76% and 23.47% respectively with the period under review. This result shows that the amount of runoff generated in the study area is to be so high since there was an increase in both built-up area and bare lands from 28.93% as of 2005 to 39.61% in 2015 and to 59.16% in 2020. The implication here is that as at 2020, 59.61% of the entire landmass of the area is either bare, cemented or roof topped, hence preventing

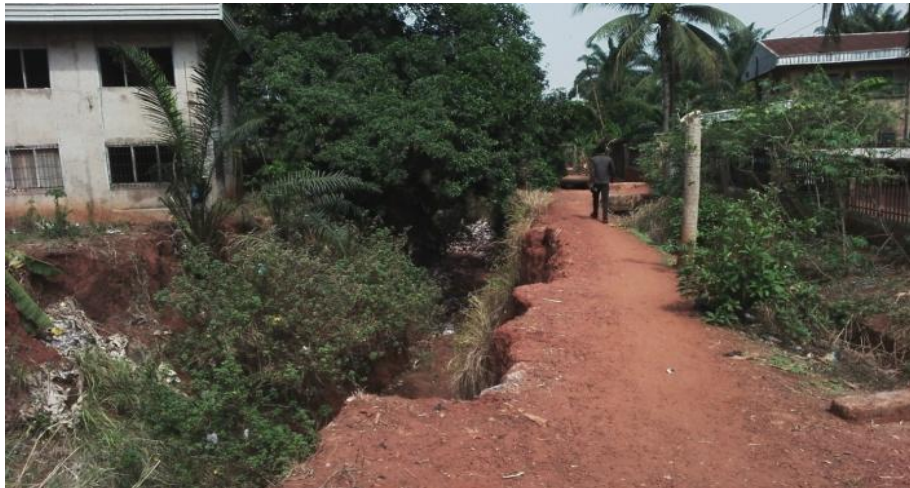
**Plate H. Gully cut at Ibeziako Street with the street reduced to a footpath and house endangered by the gully in 2016**

Erosion affect human life negatively, destroy properties, cut off roads, brought down electricity poles, collapsed pipe lines, culverts and bridges, etc (Plates H - L)

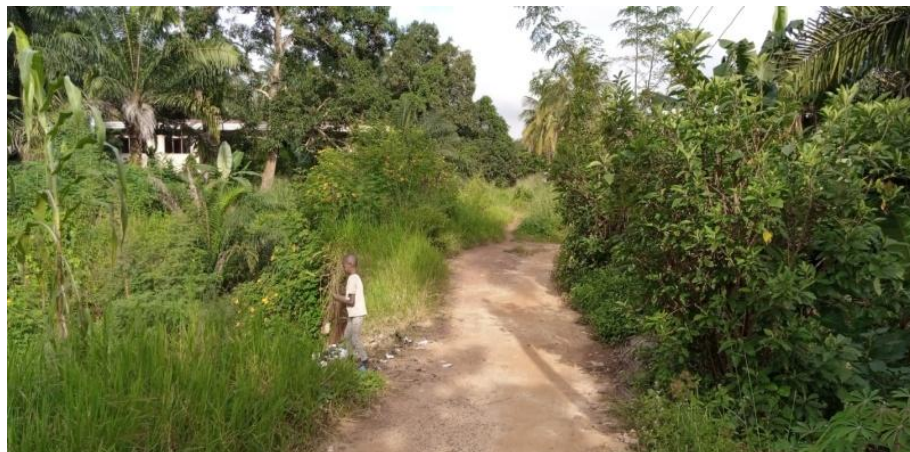
**Plate I. The same gully cut at Ibeziako Street with the reduced street totally cut off and the endangered houses abandoned in 2020**

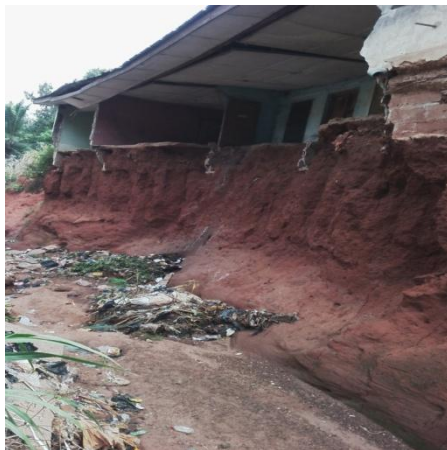
**Plate J. Property partially destroyed by the gully in 2016**

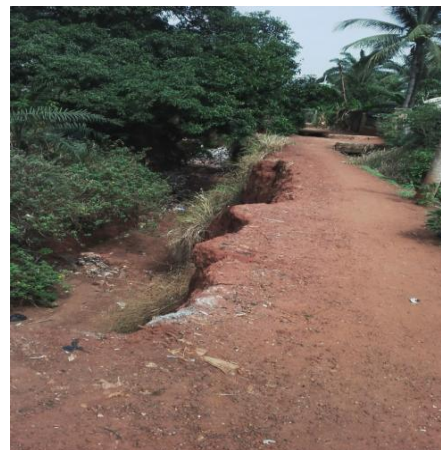
**Plate K. A full size street reduced to foot path**

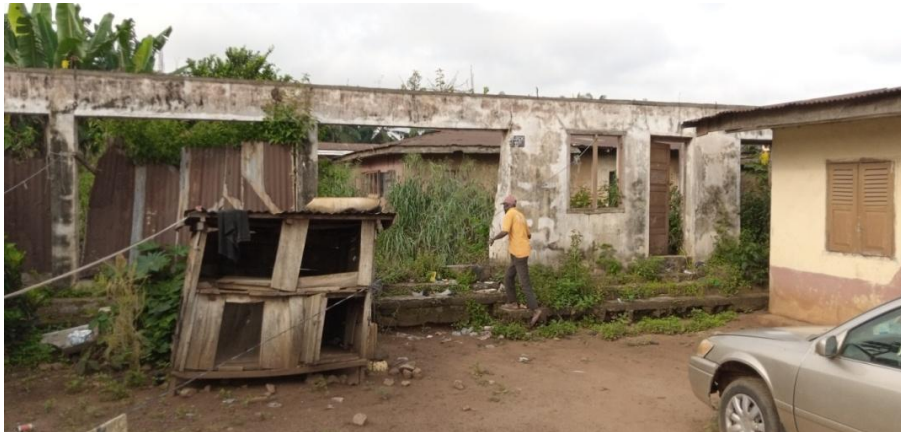
**Plate L. The same property completely destroyed by the gully in 2020**  
*Source: Authors Fieldwork, (2016 and 2020)*
