Repair and Strengthening of R.C Flat Slab Connection with Edge Columns against Punching Shear

Original Research Article

Aims: Study the repair and strengthening of the flat slab-edge column connections against punching shear.

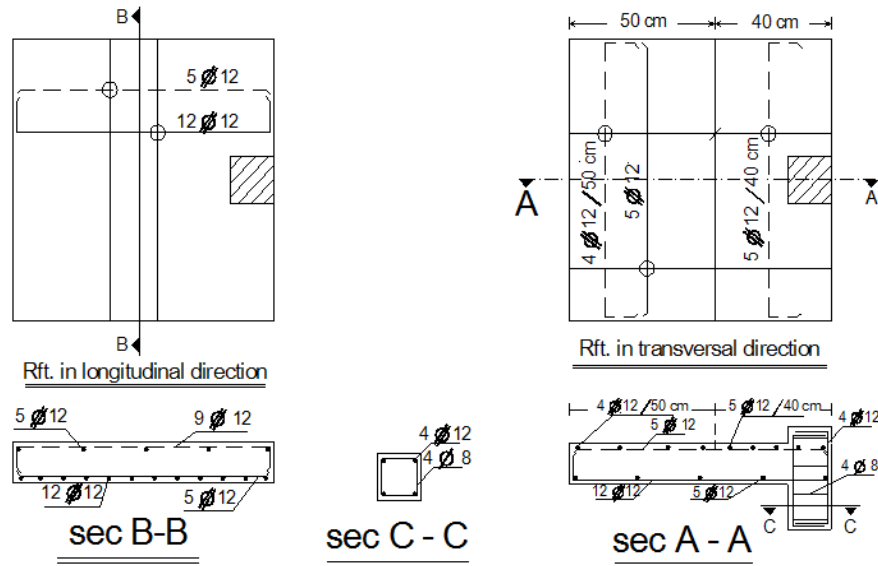
Fig. 2. Full details of the specimen reinforcement

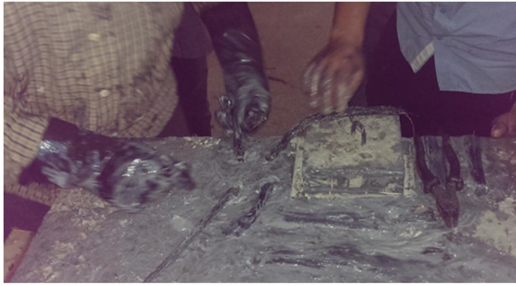
Fig. 4. Manufacturing of GFRP stirrups

The E-glass fibers used to produce the GFRP stirrups were sika wrap Hex-430G, which is a product of sika company, and the used polymer was polyester. High strength carbon fibers manufactured by Sika Company under trade name Sika Wrap Hex-230C and epoxy Sikadur-330 are used to produce the CFRP stirrups. The Mechanical properties of the used fibers are given - according to the manufacturer- in Table 3.

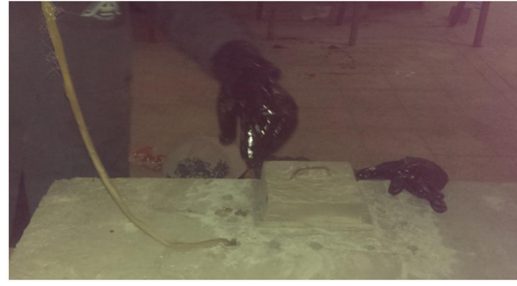
Fig. 5. Manufacturing of CFRP stirrups

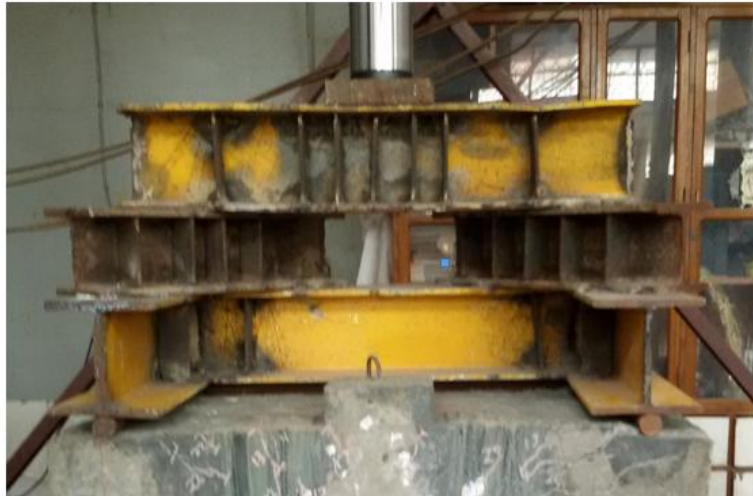
Fig. 7. The rigid steel system used to distribute the concentrated load

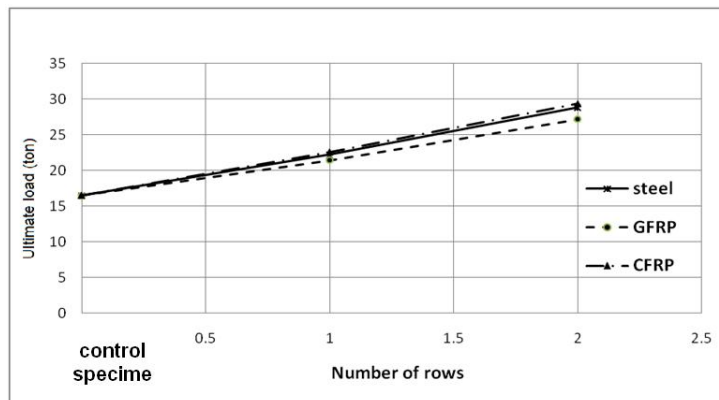
Fig. 21. Effect of the number of repair rows on the ultimate punching shear resistance

regularly around the reinforced zone up to the failure but in case of strengthening brittle failure occurred in the outer zone suddenly. Figs. (20 & 21). Show the material type and number of stirrups rows effect on the ultimate punching shear resistance Table 4. Also,

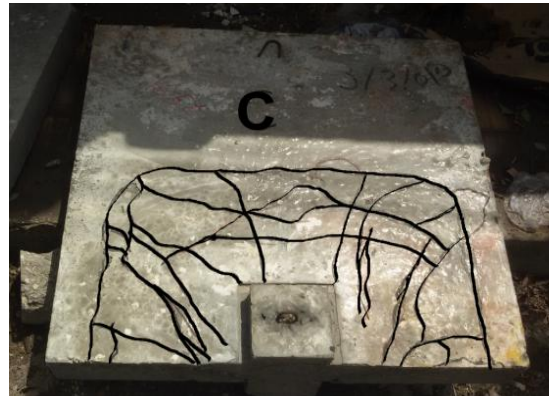
Fig. 22. Cracking pattern of specimen (C)

All the tested specimens were loaded until failed due to punching shear. For all specimens, the first crack was recorded, cracks propagation were monitored, and the mode of failure was determined. Table 4 shows the load value corresponding to cracking initiation (V_{cr}). Strengthening and repair systems led to an increase of the first crack load. Cracks began firstly at the slab compression side near to the column edges. As the applied load increases the number and width of the cracks increase and new cracks develop and began to propagate in radial directions towards the slab edges. Also, fine cracks were observed running from column edges at tension side towards the slab edges in the three directions. For all the tested specimens, it was observed that the column penetrated the slab at failure and the upper perimeter crack had a semi - rectangular shape at the slab tension face.

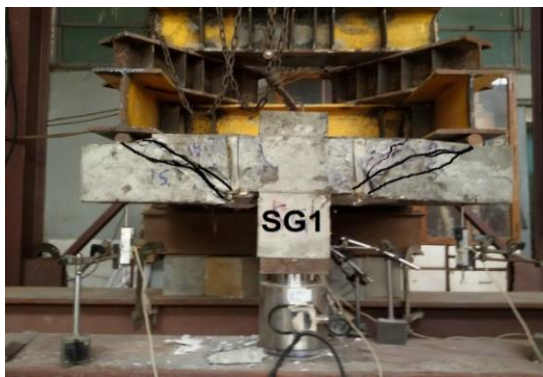
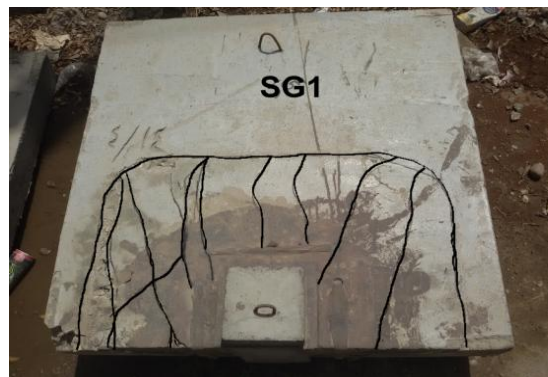
Fig. 23. Cracking pattern of specimen (SG1)

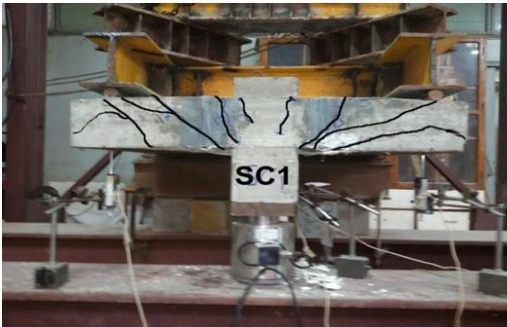
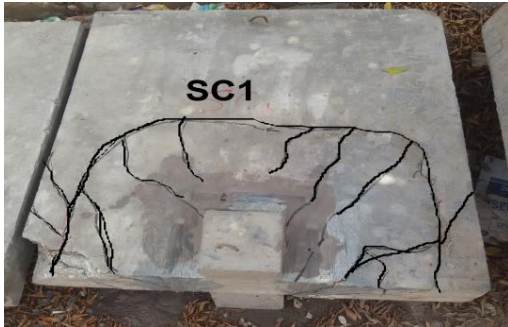
Fig. 24. Cracking pattern of specimen (SC1)

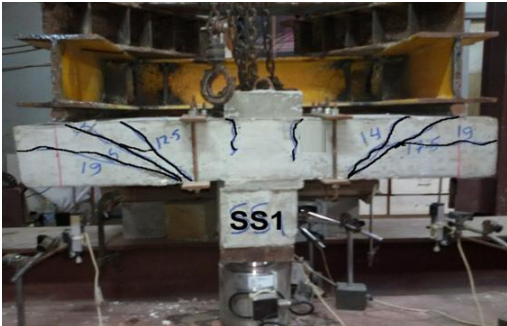
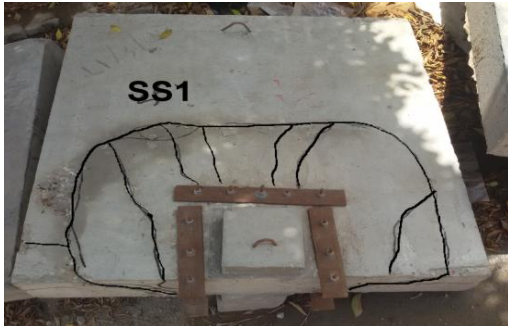
Fig. 25. Cracking pattern of specimen (SS1)

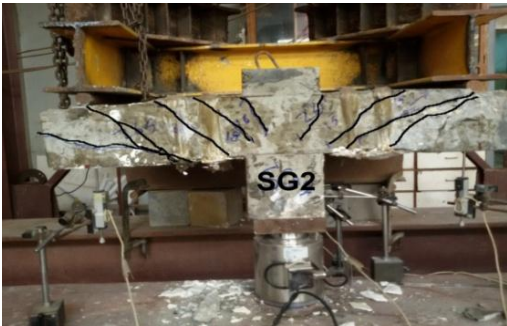
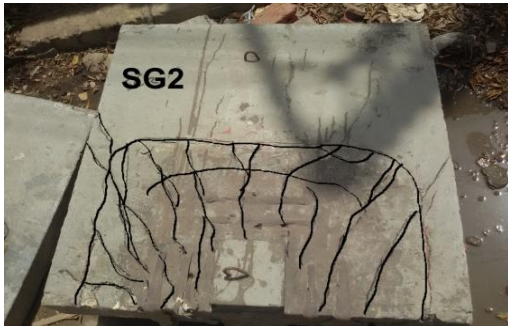
Fig. 26. Cracking pattern of specimen (SG2)

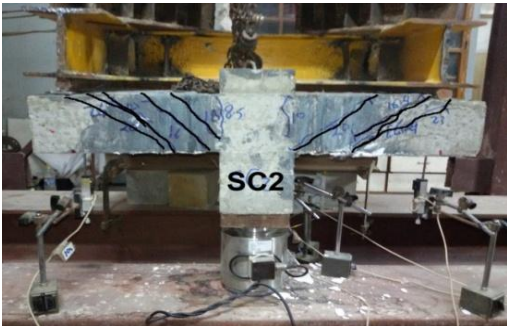
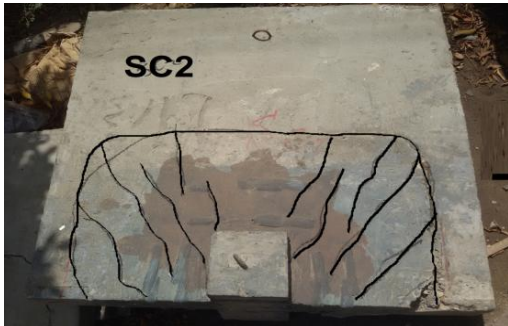
Fig. 27. Cracking pattern of specimen (SC2)

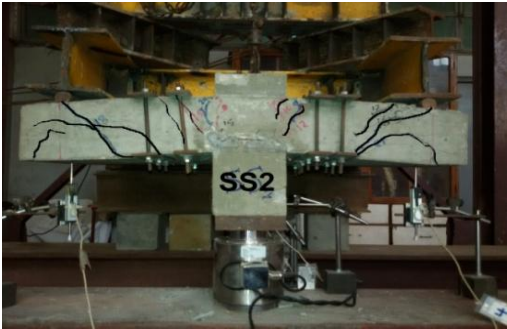
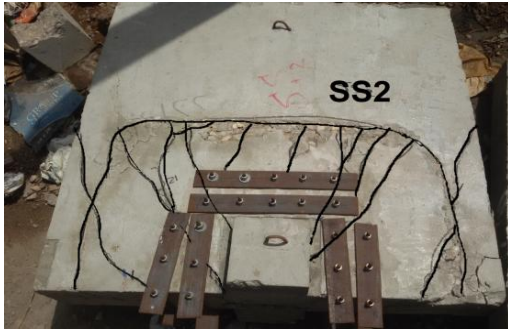
Fig. 28. Cracking pattern of specimen (SS2)

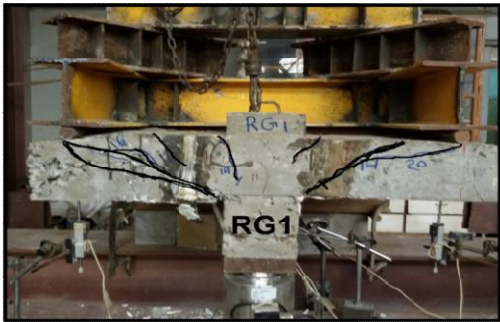
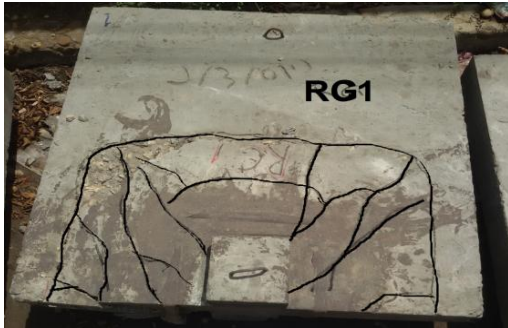
Fig. 29. Cracking pattern of specimen (RG1)

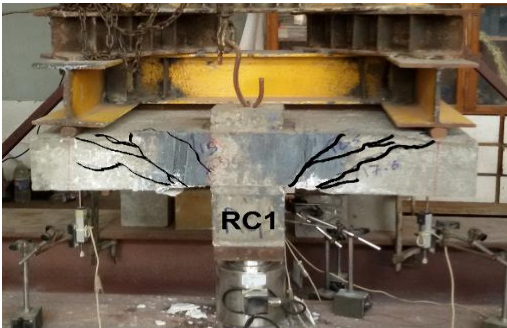
Fig. 30. Cracking pattern of specimen (RC1)

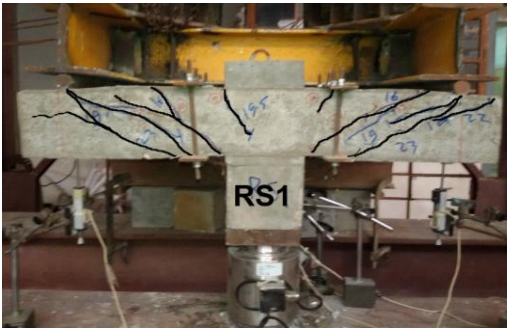
Fig. 31. Cracking pattern of specimen (RS1)

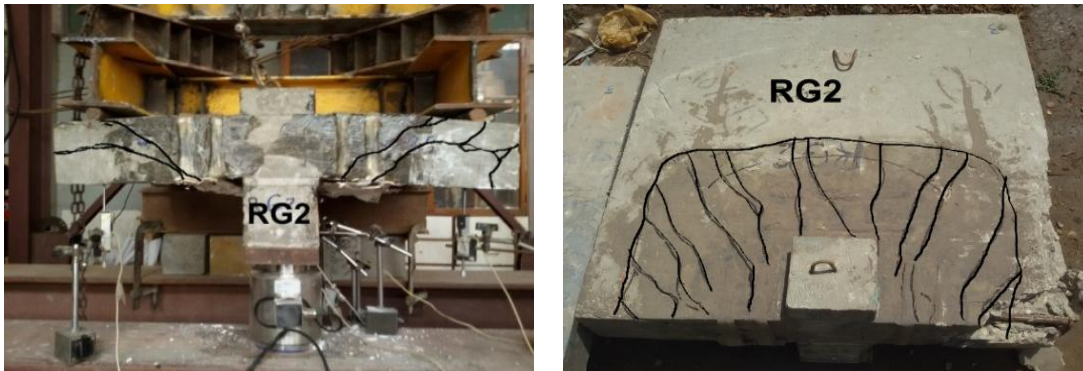
Fig. 32. Cracking pattern of specimen (RG2)

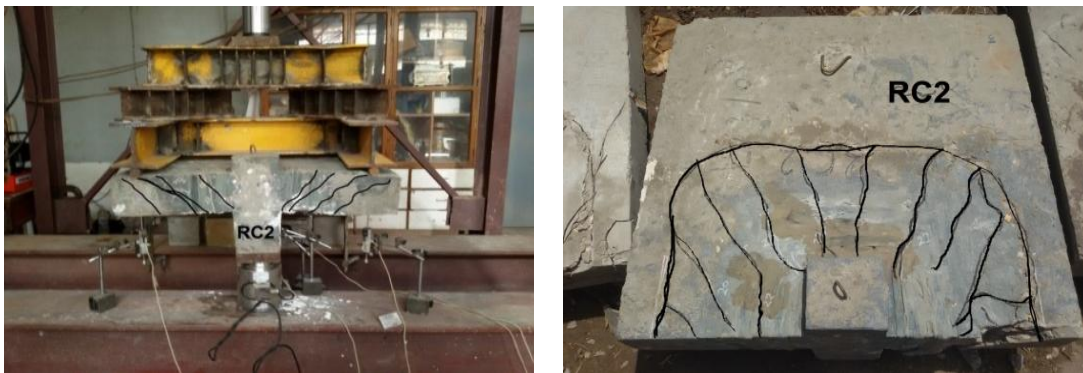
Fig. 33. Cracking pattern of specimen (RC2)

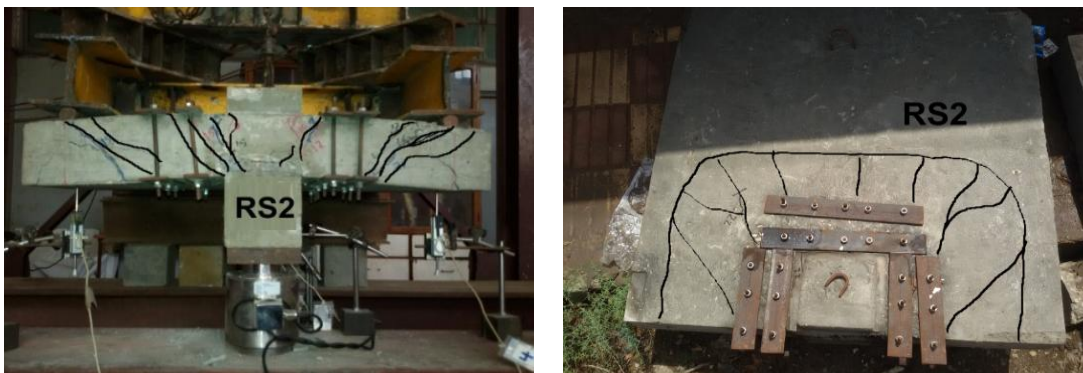
Fig. 34. Cracking pattern of specimen (RS2)
